Southeast Tornado MAT

Daily Report

Wednesday, 11MAY2011

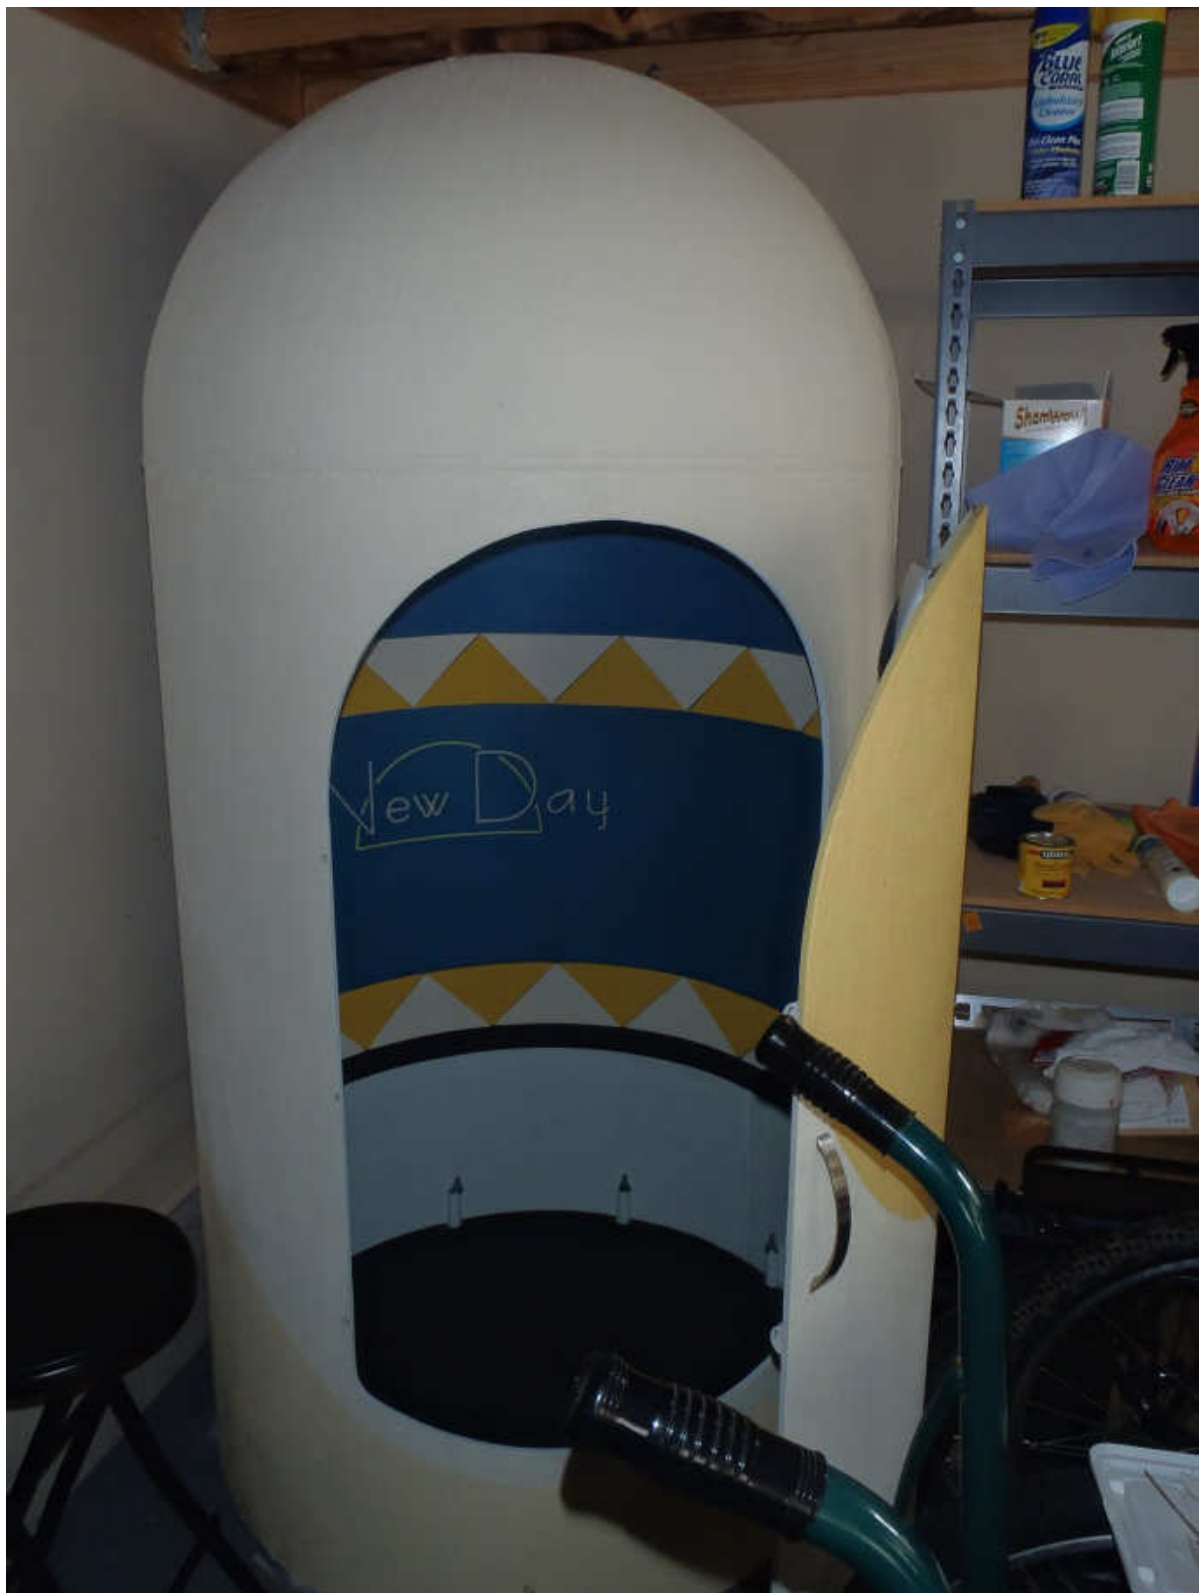
NSSA Tested/Approved Safe Room in Huntsville, AL

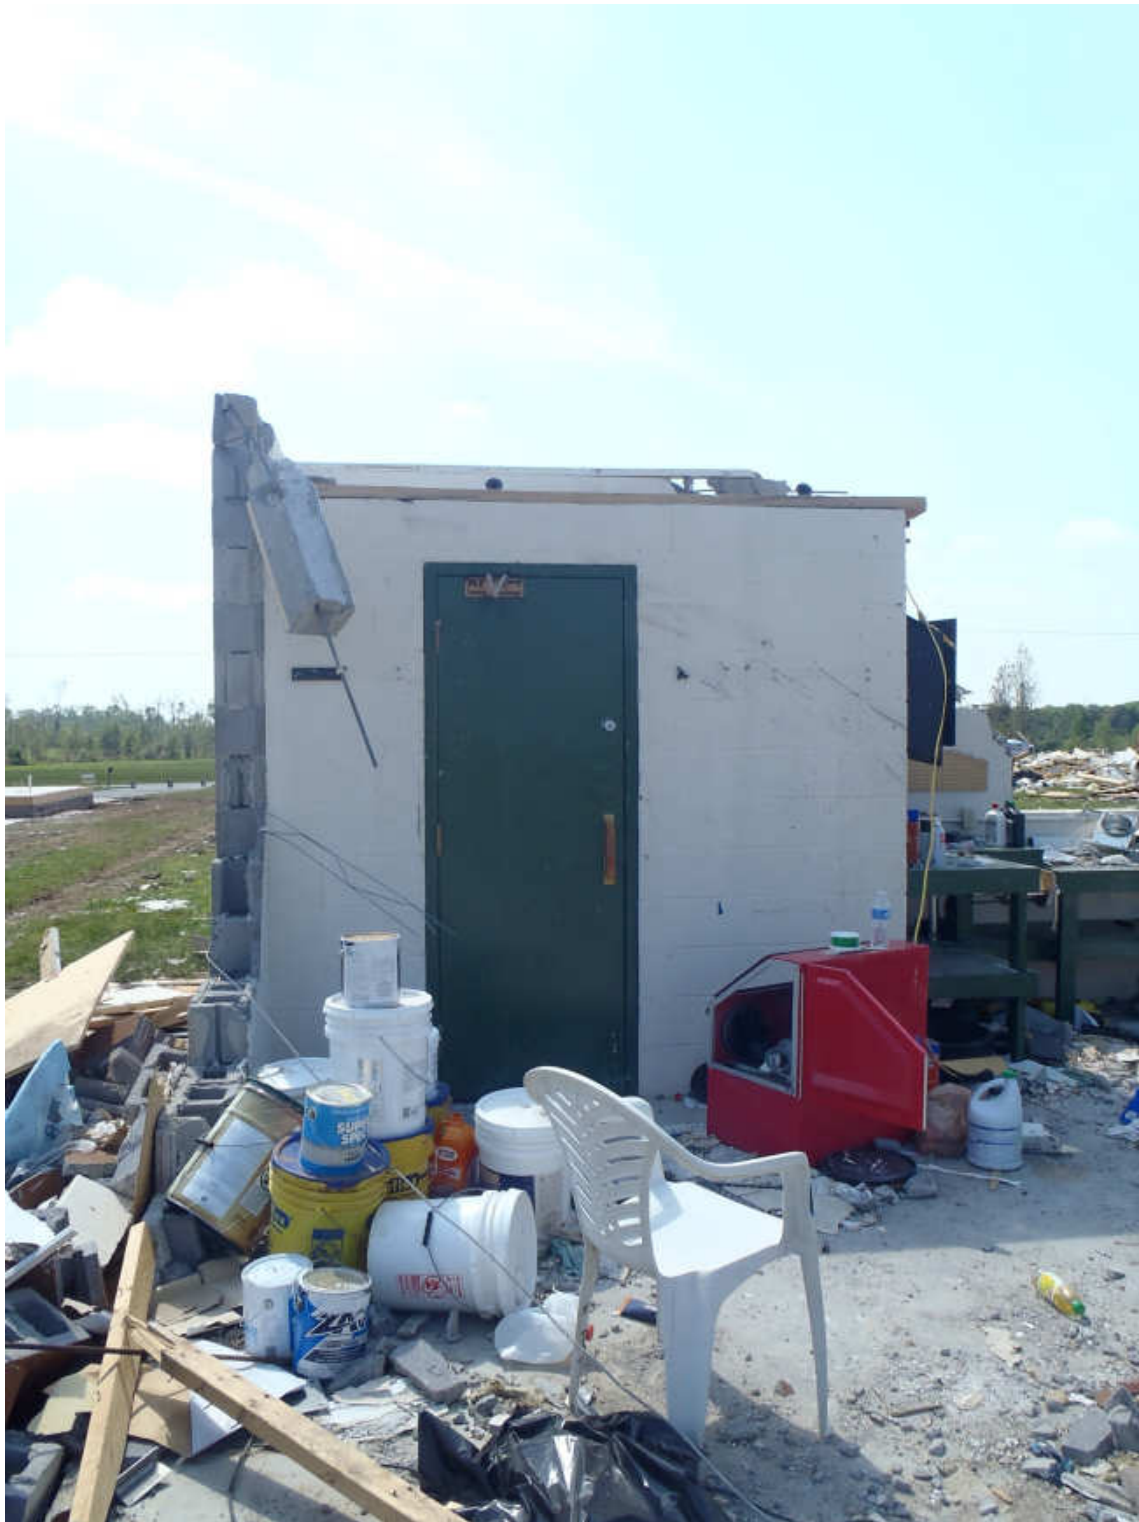
Following the manufactured homes we visited Athens, AL. The town suffered damage to several residential neighborhoods. One family in particular was photographed and highlighted in the news reports – the Harrison family in Athens, AL. We were able to located and photograph their safe room, which was built into their garage and was in the direct path of the storm. In addition, the team was able to visit several NSSA approved safe rooms.

The Harrison Family Safe Room
